Environmental Exposure Report

Depleted Uranium in the Gulf

Last Update: July 31, 1998

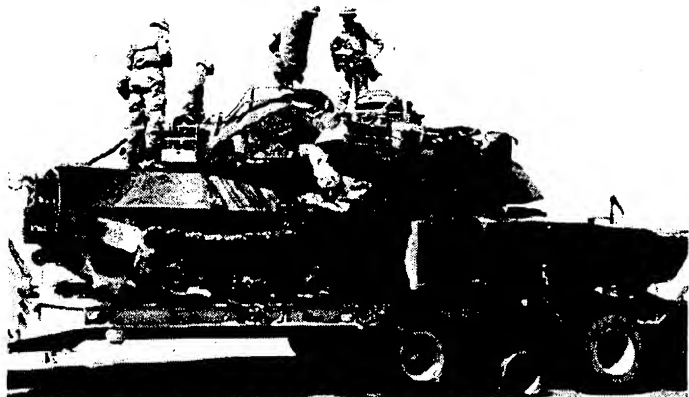
Eight friendly fire incidents involving US M1A1s destroying or damaging occupied US-crewed vehicles with DU munitions occurred during the Gulf War. These incidents (distinct from non-DU friendly fire incidents or cases where friendly vehicles were evacuated and then deliberately destroyed to prevent their capture) resulted in the contamination of six M1/M1A1 tanks and 15 Bradley Fighting Vehicles. Another M1A1 was hit by a large shaped-charge round, believed to be a Hellfire missile fired from an Apache helicopter, that ignited an on-board fire. This incident is described in the "Tank Fires" Section (Tab J). Darkness and low visibility caused by heavy rains, sandstorms, etc., were major contributing factors in all of these incidents.²³

Figure 6 - M1A1 lost to friendly fire

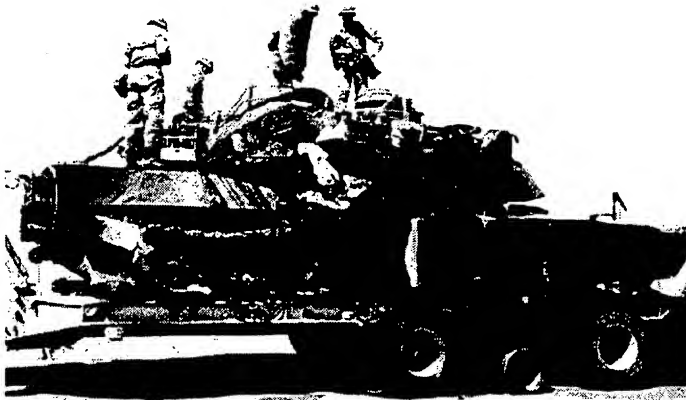
Figure 22 - M1A1 lost to friendly fire

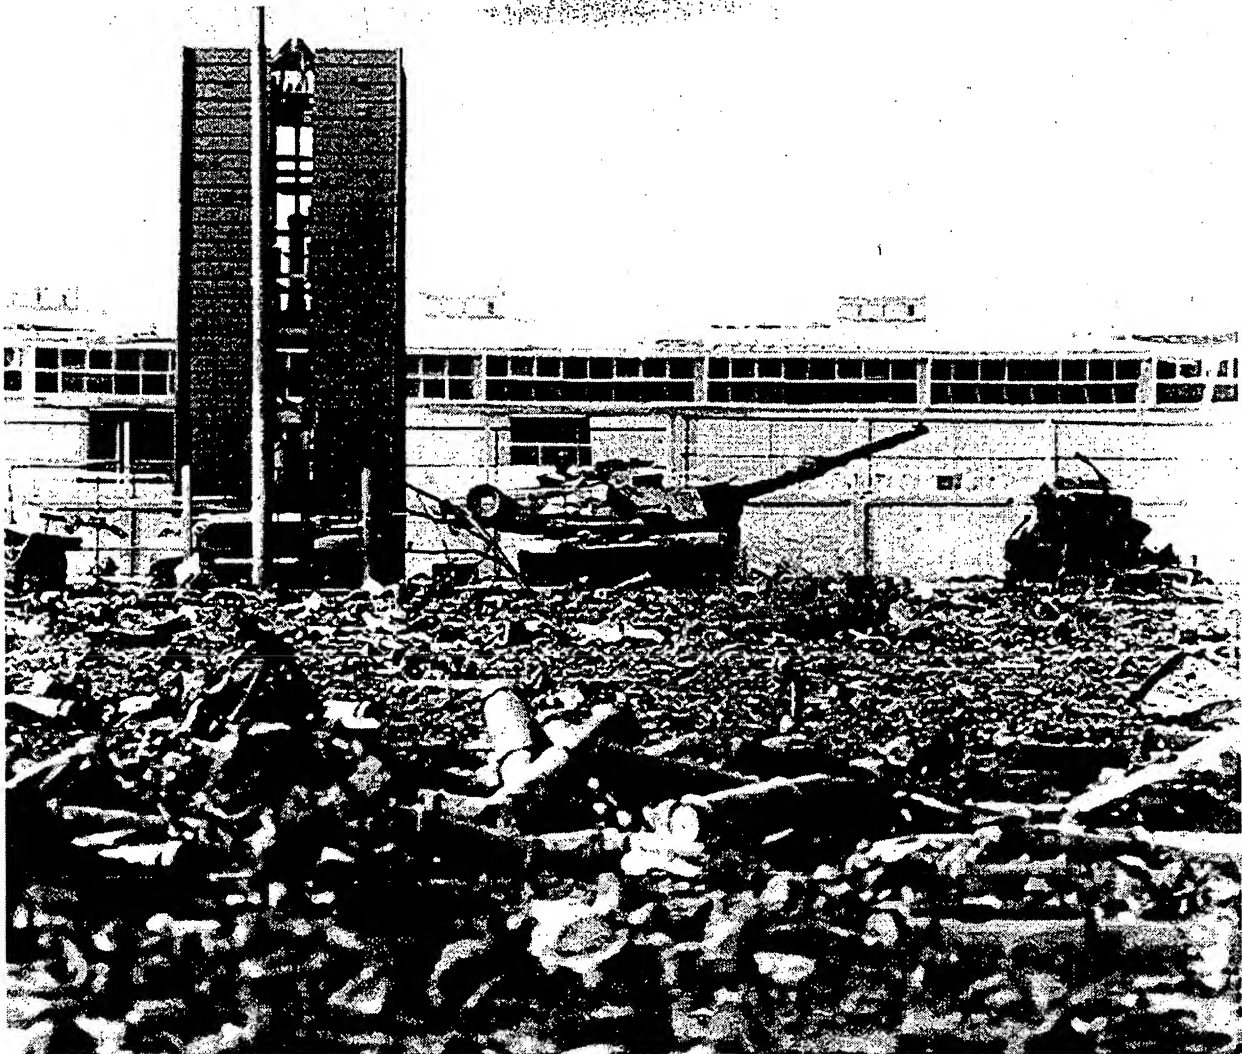
Figure 29 - Aftermath of Doha motor pool fire (view of washrack area) showing armor hulks and UXOs.

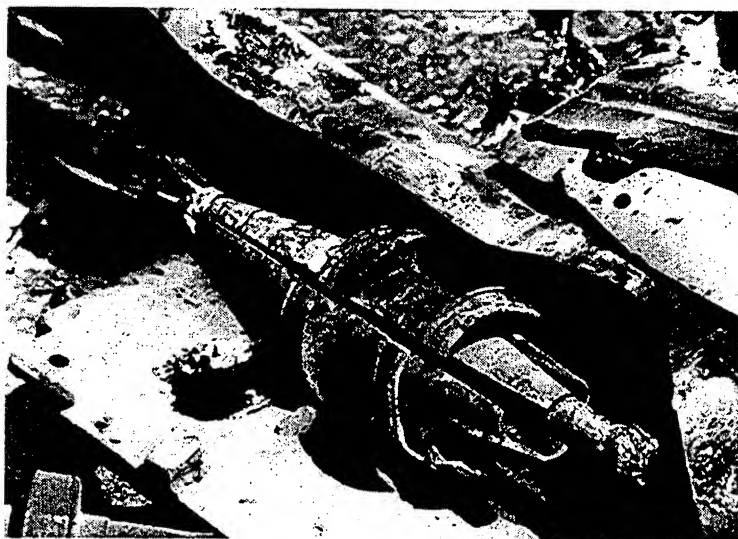
Figure 30 - Burned DU rod and sabot

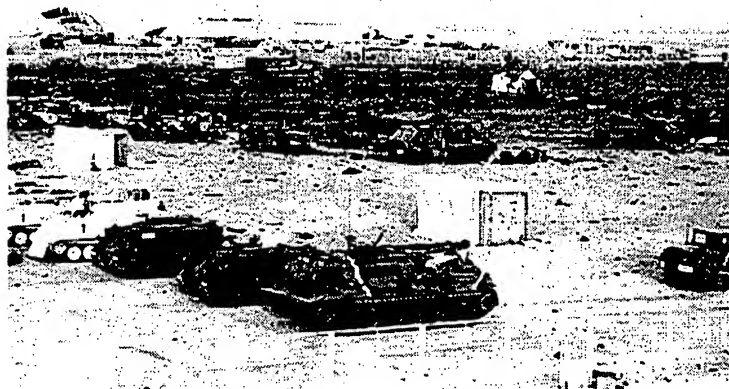
Figure 31 – Aftermath of Doha motor pool fire

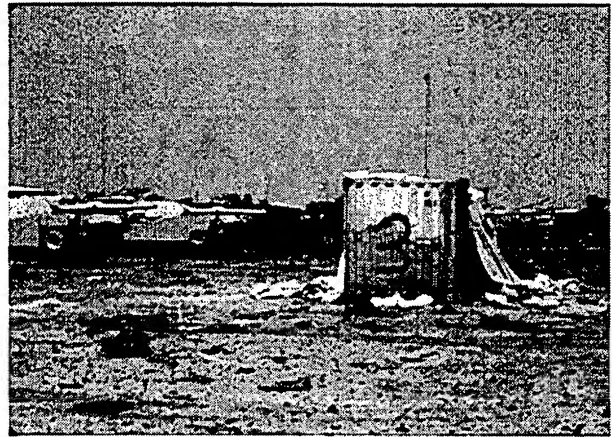
Post-blast photos show many intact conexes among the burned-out wreckage (figure 34). The commander of the 146th Ordnance Detachment (EOD) stated that stored ammunition is more stable than is generally believed, and is fairly survivable except when directly exposed to fires, extreme heat, or explosions. Even in the conexes that blew up, typically only a few shells would detonate, scattering the other rounds rather than touching off a massive "sympathetic" detonation. This explains the huge quantity of unexploded ordnance (UXOs) littering the motor pool area.²²³ Large numbers of the lightweight

Figure 34 - Surviving Munitions Conex

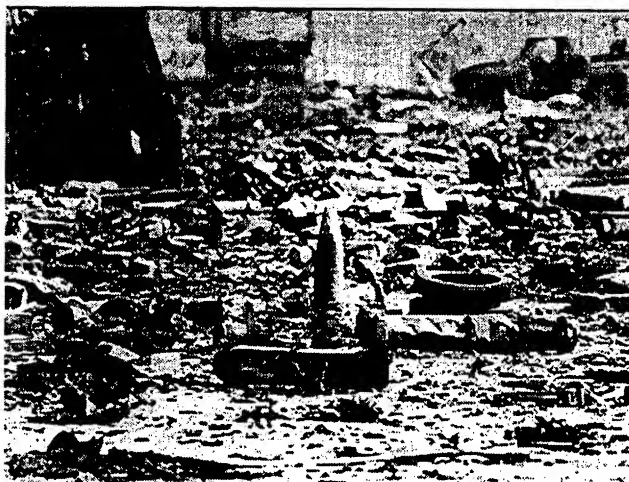
EOD members viewed the staggering quantities of UXOs they had to contend with as the most grave and immediate threat at Doha. By its nature, explosive ordnance disposal is an extremely dangerous undertaking, and the sheer magnitude of the task facing the 146th Ord Det. at Doha cannot be overstated. These hazards were tragically underscored on July 23, twelve days after the initial blast and fires. Two senior EOD non-commissioned officers and a 58th CEC soldier died instantly in an accidental UXO blast. The fatal mishap had a significant impact on the remainder of the cleanup effort, and, particularly, on the 146th Ordnance Detachment.

Figure 36 - UXOs in Doha's North Compound

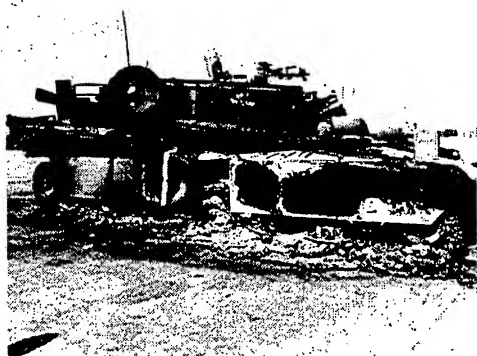
All four of the M1A1s were damaged/destroyed as a result of fires external to the vehicle. *There were no penetrations anywhere of the exterior armor* (emphasis added). Three of the four M1A1s had their fuel and ammunition destroyed. In these three cases, there was an explosion in the ammunition compartment. The ammunition doors and blowout panels functioned properly, keeping the blast from entering the crew compartment. The fourth M1A1 was damaged on the right suspension only, and except for the gunner's computer and transmission warning lights, was completely operational.²⁵¹

Figure 40 - Burned-out Doha M1A1

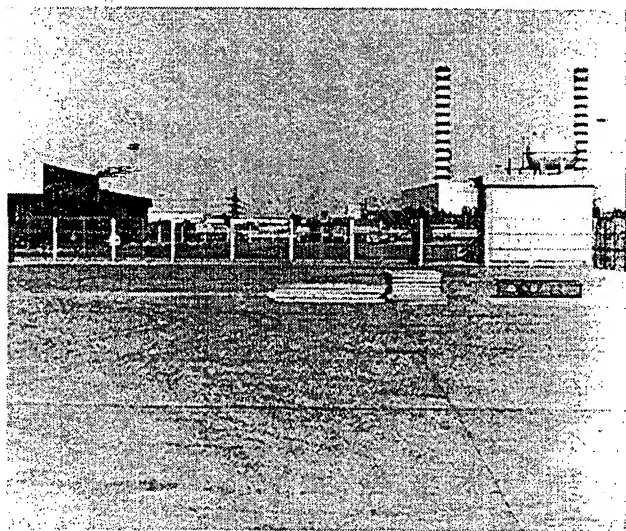
Figure 43 - Doha motor pool pad after cleanup

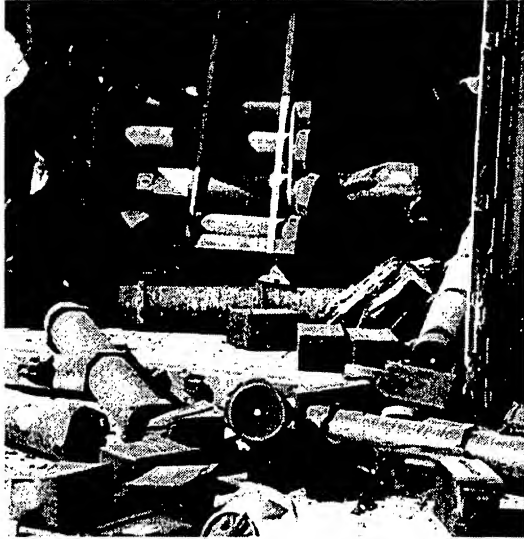
Figure 44 - Unexploded DU rounds
